. 1				
State of Washington Department of Ecology Northwest Regional Office WATER COMPLIANCE INSPECTION REPORT						substitute for OMB No. 2040- 0057 and EPA form 3560-3 (Rev. 9-94) (last file update 12-95.)					
	Section A: National Data Sy	stem Codina	(i.e., PC	S)							
Transaction Code	NPDES #	yr/mo			ction Type	In	spector	Fac Type			
1 N 2 5	3 WA-003196-8 11	12 13/07	-		18 <b>R</b>			20 2			
	Remar	ks									
Inspection work days	Facility Self-Monitoring Evaluation Rating		BI	QA	T	Reserved					
67 <b>0.2</b> 69	70 2	7	71 <b>N</b>	72 <b>N</b>	73	_74 7	5	80			
	Section B: Fac	cility Data									
Name and Location of Facility Inspected (For industrial users discharging to POTW, also include Entry Time/Date Permit Effective Date											
POTW name and NPD			1				10.1.10=				
	METAL CORPORATION			1:00 PM 12/13/07 12/01/07  Exit Time / Date Permit Expiration Date							
601 S. MYRTLE STRE SEATTLE, WA 98108					/ Date // 12/13/0	17		xpiration Date

SEATTEL IRON AND METAL CORPORATION inspected  $\underline{\textbf{13/07/12}}$  by Ed Abbasi P.E. Page 4 of 5

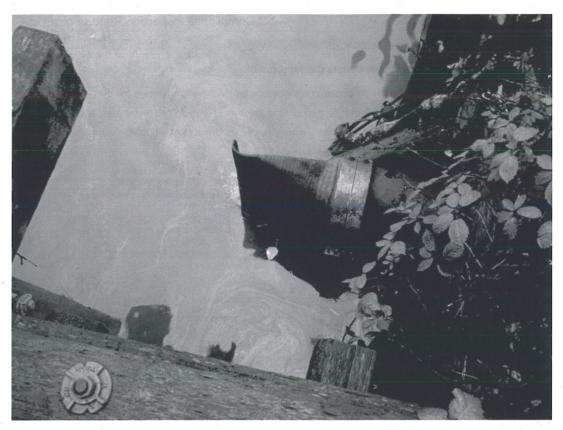
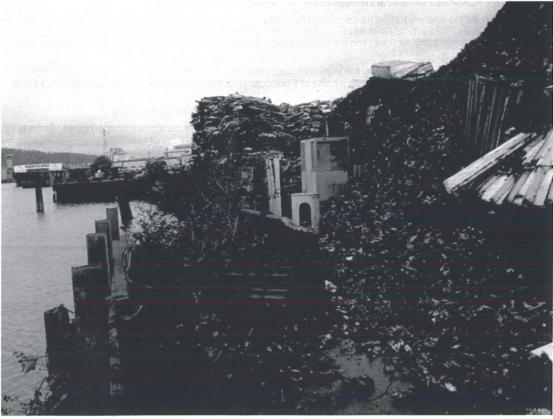
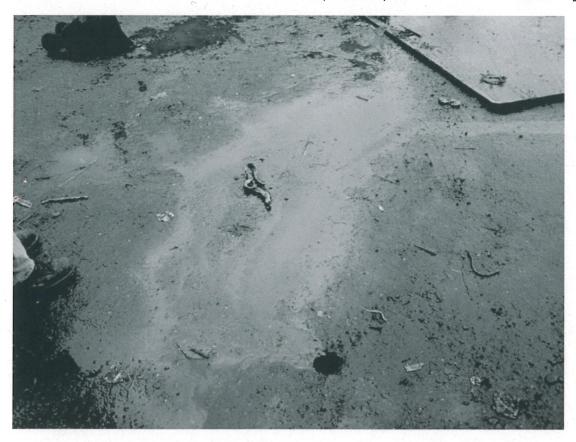
some plastics are landfilled. The facility had been operating under administrative order that was issued on May 28, 1999 and general											
permit # SO3003645C. A new permit was issued in November 2007 that became effective on December 1 <sup>st</sup> . The site appeared to have excessive stockpiles <del>amount</del> of recyclable materials that needed be removed as soon as possible. The site appeared to have been pushed											
to its limits. The stormwater on site appeared to be extremely contaminated and viscous. We did not notice any applicable The											
implementation of pollution source control measures on the site were very limited. Adequate catch basins inlet protection was missing											
specially, the. They appeared to be filled with extremely dirty/oily runoffs. Failure to properly control the pollution at its source would likely											
jeopardize the efficiency of the stormwater treatment system units. We noticed oily stormwater runoffs running on the dock that may flow to

the river instead of the treatment system. into the Duwamish. The facility was originally designed to collect the contaminated stormwater in											
an underground storage vault. The vault was designed based on 5 year- 24hr. Runoff as a result of storms larger than the design storm is discharged directly to the river. The treatment plant starts operation and treatment when wastewater collected in the vault reaches a certain
